City of Alexandria Storm Sewer Capacity Analysis (CASSCA)

Strawberry Run Condition Assessment

PREPARED FOR: City of Alexandria, CH2M Hill
PREPARED BY: Michael Baker Jr., Inc.
DATE: February 14, 2014 (Revised May 26, 2015)

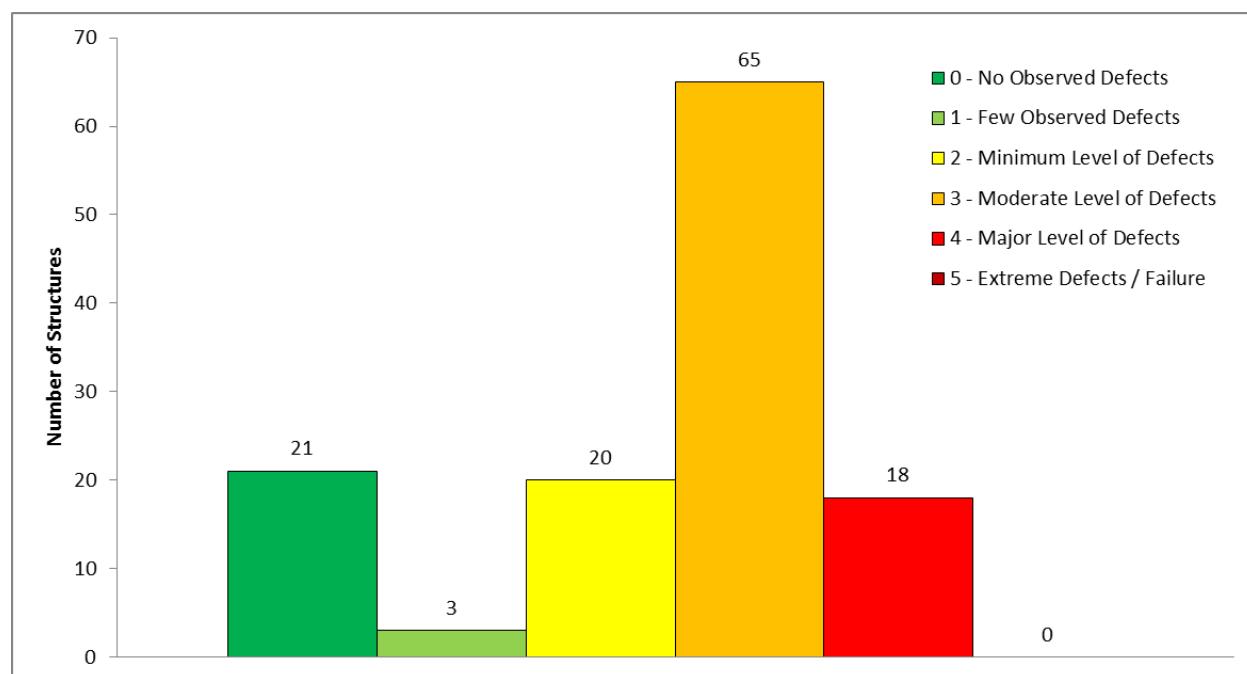
Figure 1. Structure Inspection Summary.

As part of this inspection task, 127 storm structures were inspected in the Strawberry Run watershed. Figure 1 shows the number of structures within each defect category identified in the previous section. Figure 2 shows the geographic location of each structure within the Strawberry Run watershed, color coded to its defect category. The average condition score of the storm structures was 41 (Moderate). Eighteen (18) structures (14%) scored 61-80, placing them in the major category. About 67% of Strawberry Run structures ranked in the minimum to moderate defect categories with scores of 21 to 60. Two (2) percent of the Strawberry Run structures were rated 1-20 (Few), and the remaining 17% percent of the structures had no observed defects.

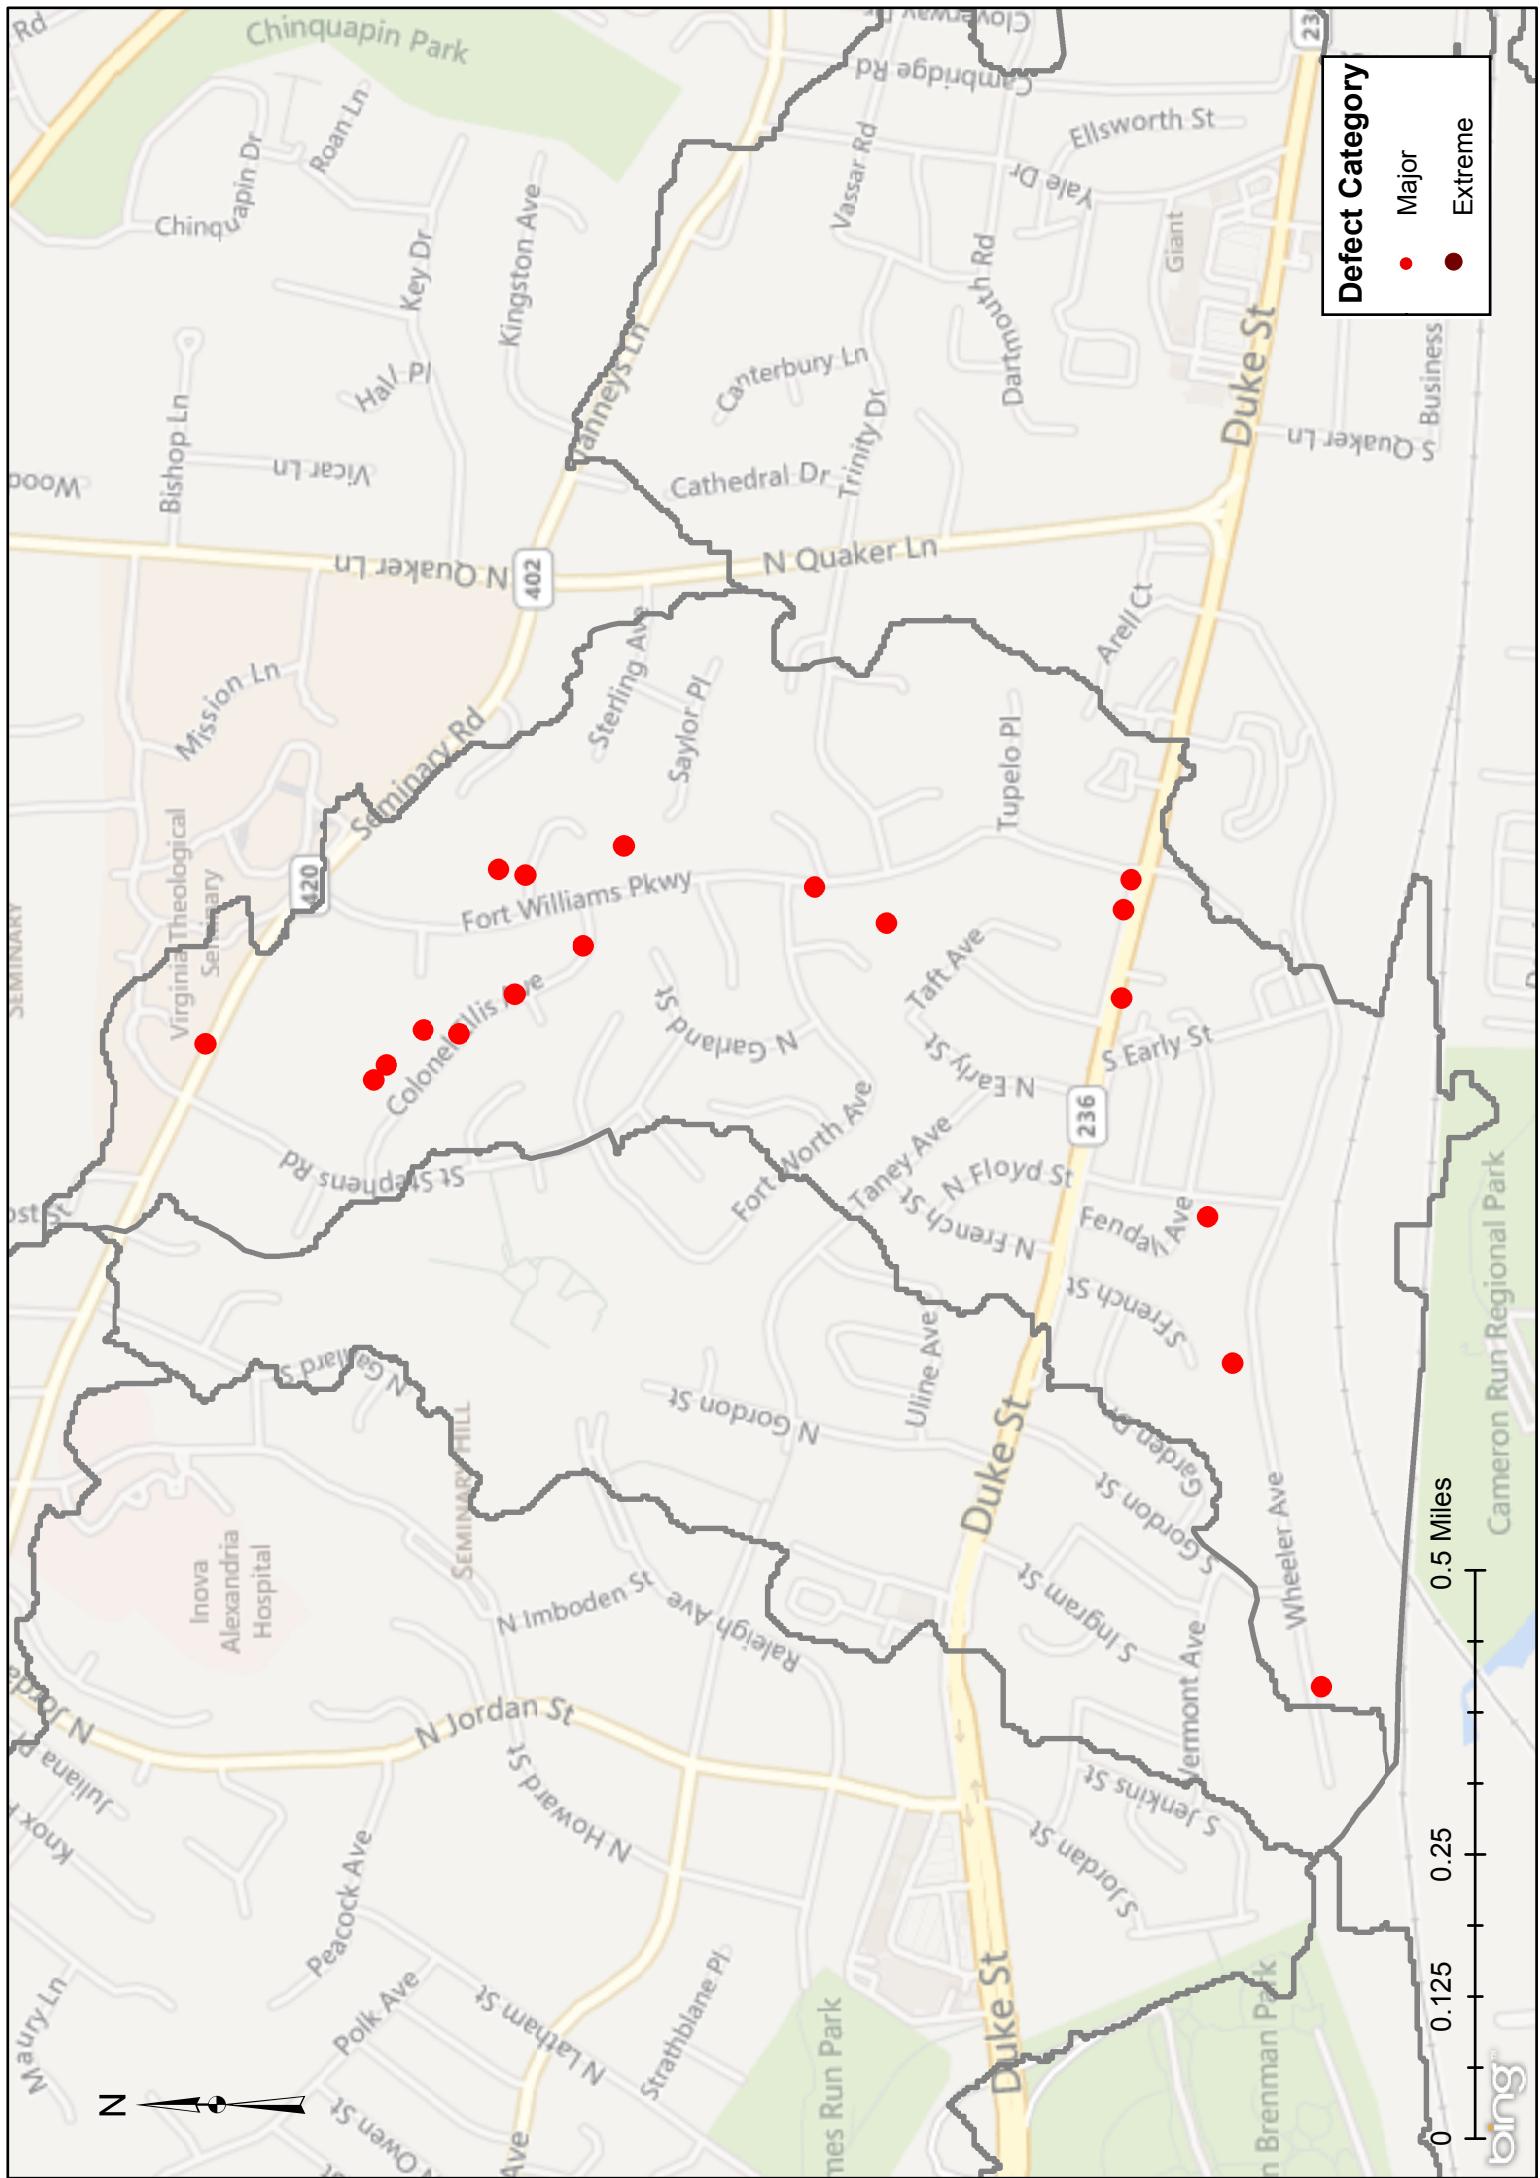
Figure 3. Location of Storm Structures in the "Major" and "Extreme" Categories (Color coded by Severity of Defects).

Figure 3 displays the location of the structures classified with major damage only. No extreme defects were observed within Strawberry Run watershed. Most structures with high defect scores are located along Fort Williams Parkway and Colonel Ellis Avenue. For further detailed condition assessment, the inspection results of the structures were broken down by structure component. Table 2 lists the number of observed defects by component and severity. Note that the table shows a count of the number of defects found in each component and their respective severity across all structures, not the number of inspections performed. Multiple defects may be found in a single component of a structure.

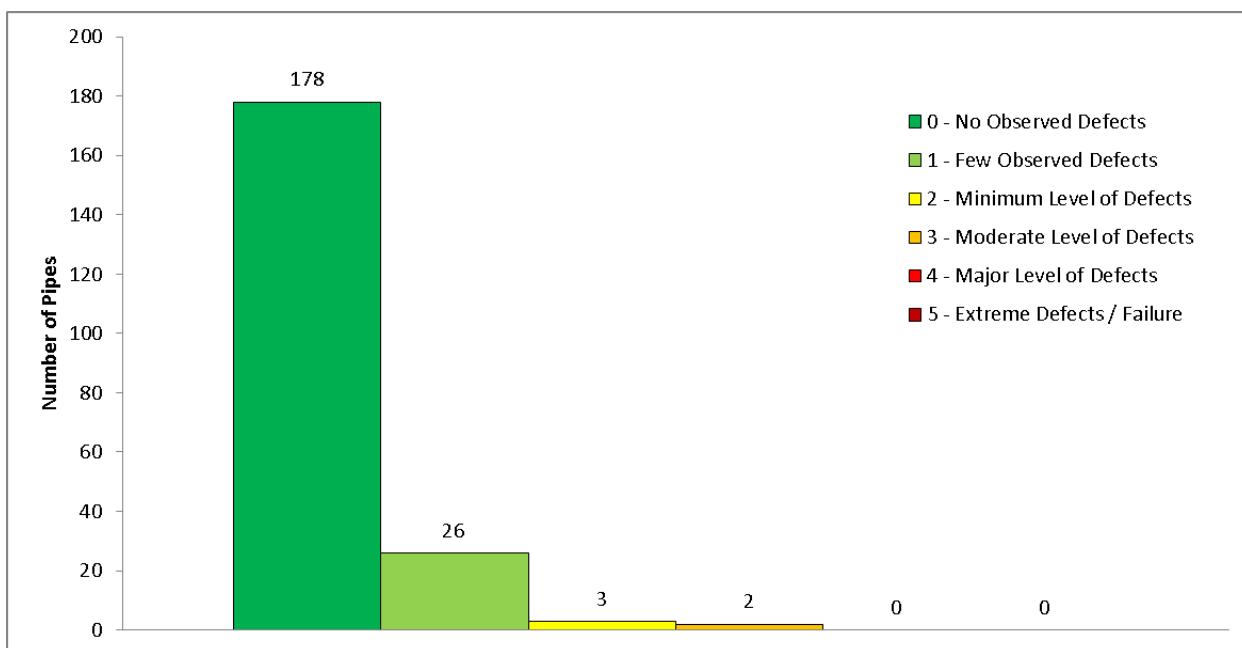
Figure 12. Pipe Lamping Inspection Summary.

In total, 209 storm sewer pipe segments were inspected in the Strawberry Run watershed. Figure 12 shows the number of pipe segments within each defect category. Figure 13 shows a map of the location of each inspected pipeline, color coded by the defect categories identified previously in the memorandum. It is noted that the majority of the defects observed were on storm pipe segments along Colonel Ellis Avenue. The average condition score of the storm pipe segments inspected within the Strawberry Run watershed was 2.0 (Few to No defects). Inspection results in Strawberry Run showed that the pipe segments were observed to be in generally good condition, with no defect observed in 85% of the pipes.
